# **INDOOR AIR QUALITY ASSESSMENT**

**Community Action Headstart  
Building One  
38 Old Groveland Road  
Haverhill-Bradford, Massachusetts**

Prepared by:  
Massachusetts Department of Public Health  
Bureau of Environmental Health Assessment  
August 2002

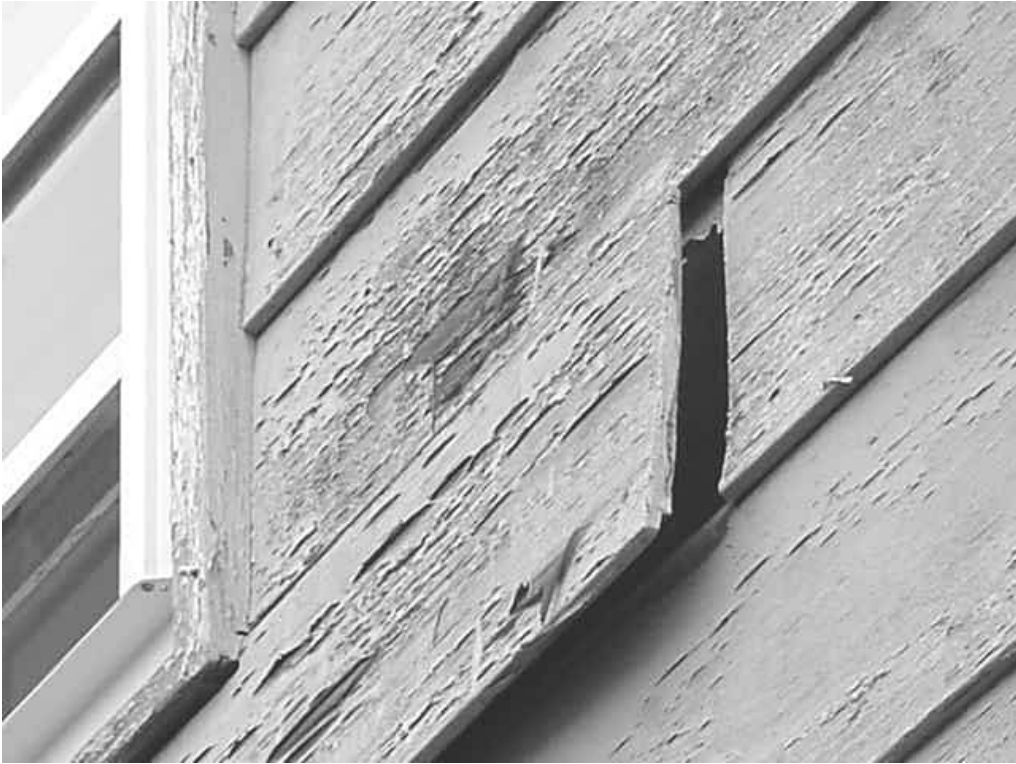
**Picture 1**

- In a large number of areas wooden siding has become detached or completely removed from the side of the building (see Pictures 1-3).
- Beneath the wooden siding is a water barrier of tarpaper, which in some cases is damaged, and/or missing (see Pictures 2-4).

**Detached Wooden Siding**

1. Examine the feasibility of installing a gutter/downspout system to parts of the building without them. Repair/replace existing gutters and downspouts that are damaged/missing.
2. Consult with architect and or general contractor regarding water tightness of the building primarily concerning the condition of siding and window frames. Have consultant assess water damaged building materials (e.g., eaves, ceilings, building envelope).
3. Replace/repair missing siding/shingles.

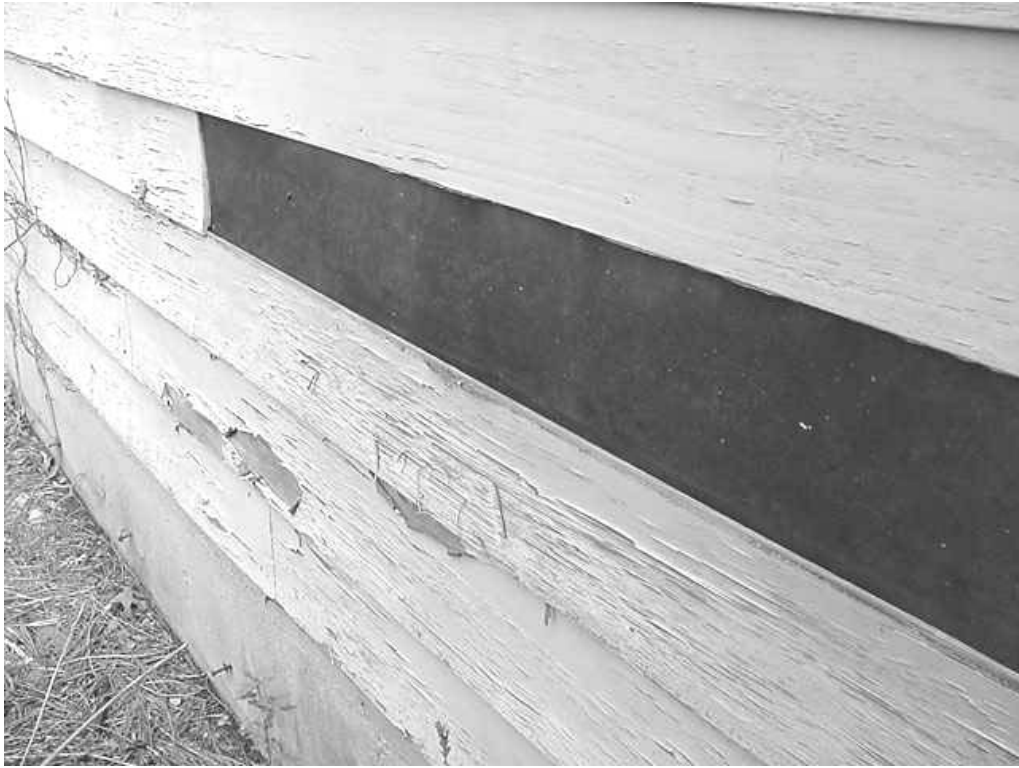
**Picture 2**

**Missing Siding Panel Exposing Tar Paper Barrier**

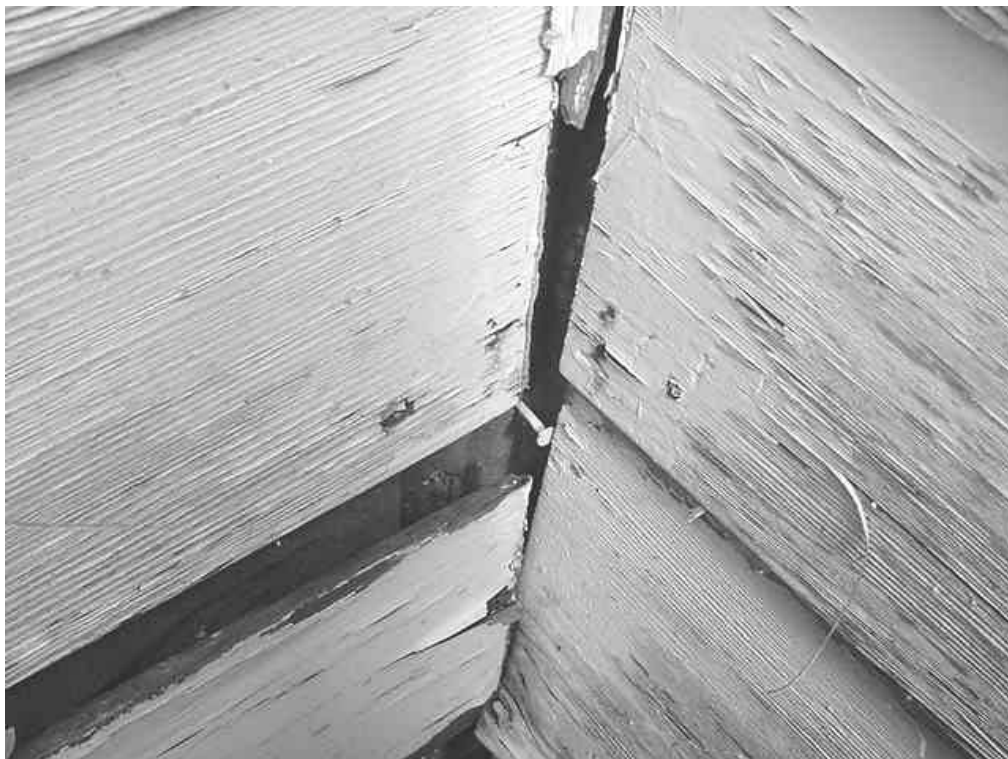
**Picture 3**

**Detached Wooden Siding**

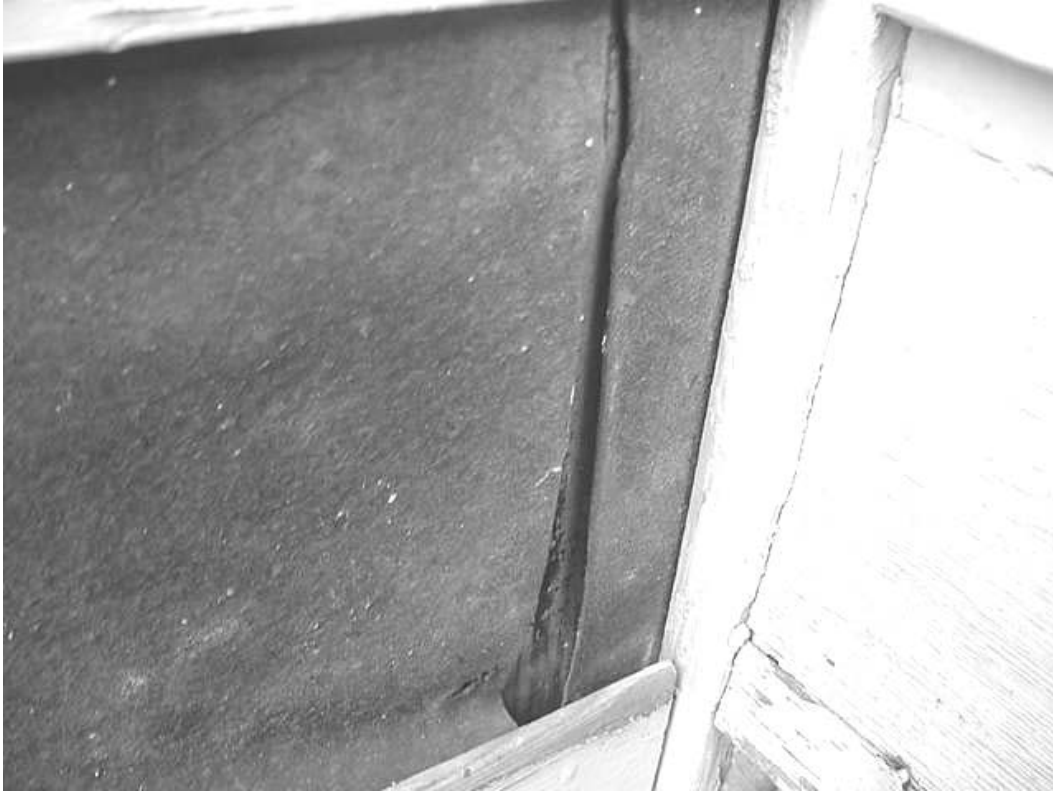
**Picture 4**

**Missing Siding/Breaches in Tarpaper Water Barrier**

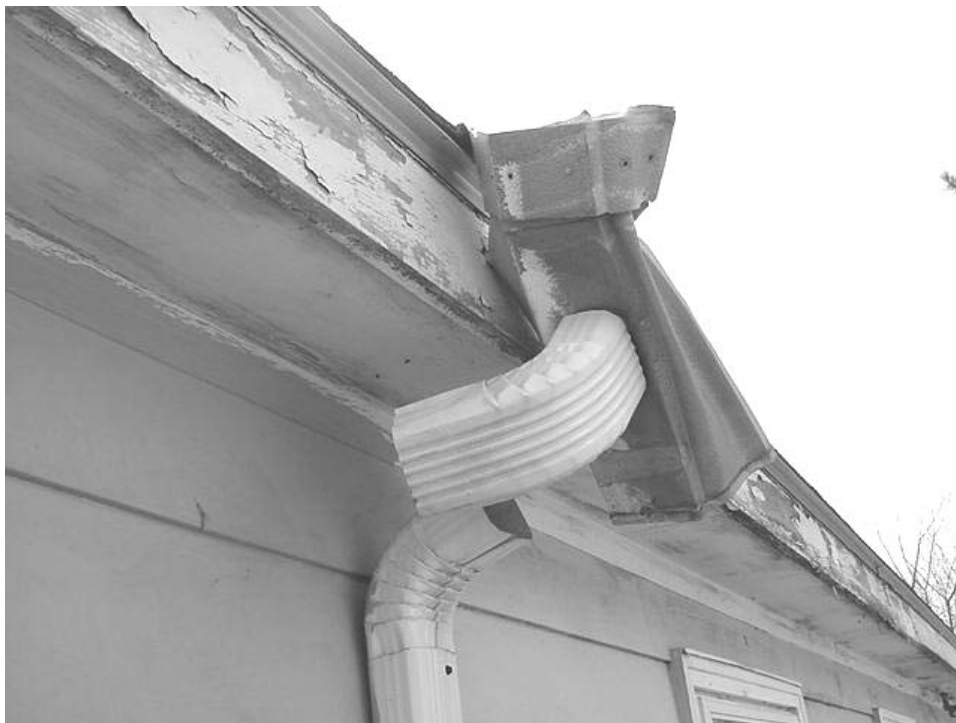
**Picture 5**

- Many areas of the building are not equipped with a gutter/downspout system. Sections of gutters/downspouts were missing parts or damaged (see Pictures 5 & 6). Incomplete or damaged gutters/downspouts can allow rainwater to run down the side of the building or pool on the ground along the foundation, dependent on wind and weather conditions. Over time, this process can allow for water penetration through the building envelope into the building.

**Missing/Damaged Downspout**

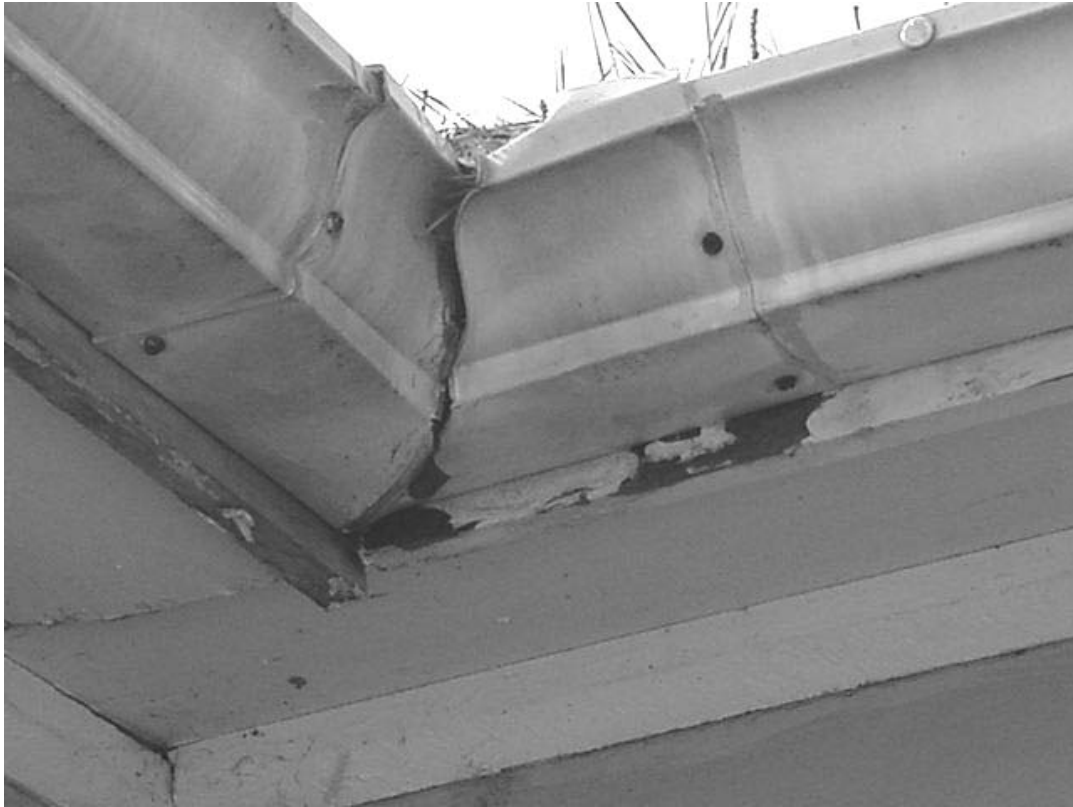
**Picture 6**

**Damaged Gutter System Note Spaces at Joint and Debris inside Gutter**

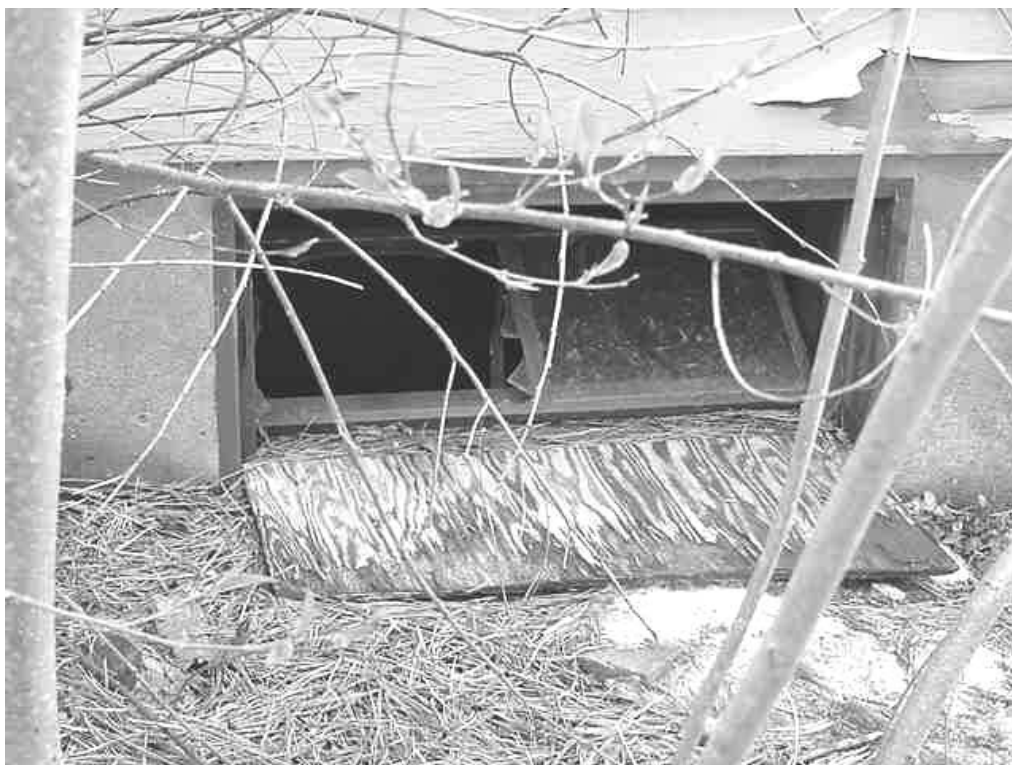
**Picture 7**

- Also noted on the exterior of the building were missing/damaged crawlspace windows (see Picture 7). Severely water-damaged wood exists under the eaves of the roof and around window frames (see Pictures 8-10).

**Broken Crawlspace Window**

4. Report any signs of water penetration to building owner/management for prompt remediation.
5. Replace/repair crawlspace windows to prevent water penetration.

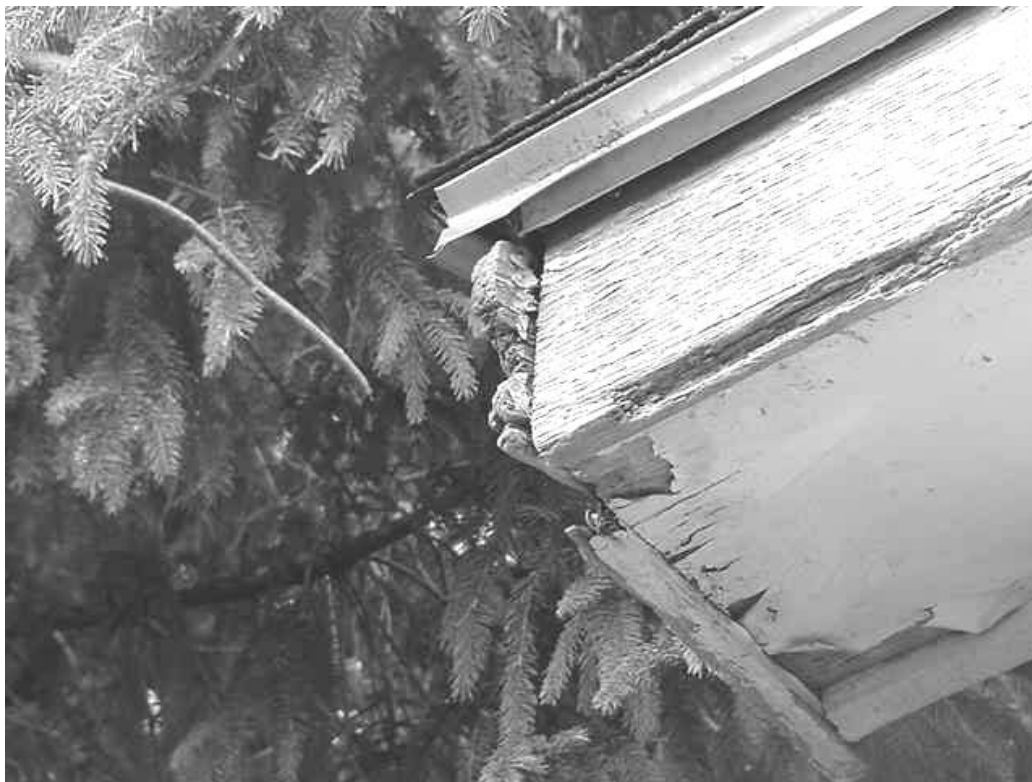
**Picture 8**

**Wood Rot Roof Eave**

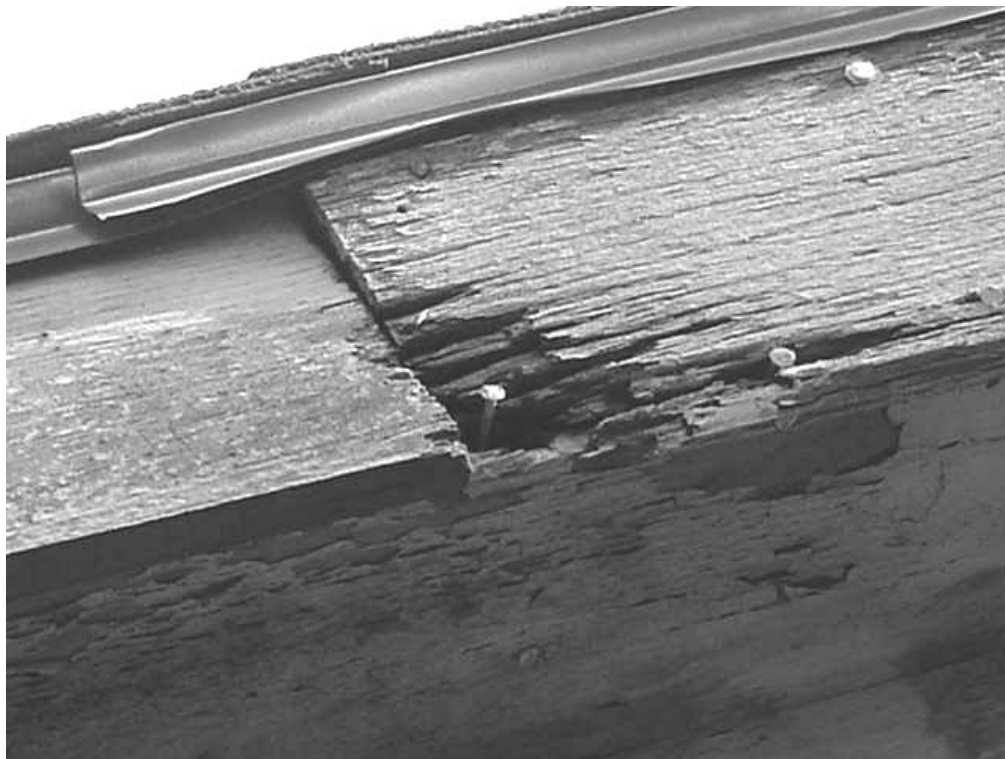
**Picture 9**

**Wood Rot Roof Edge**

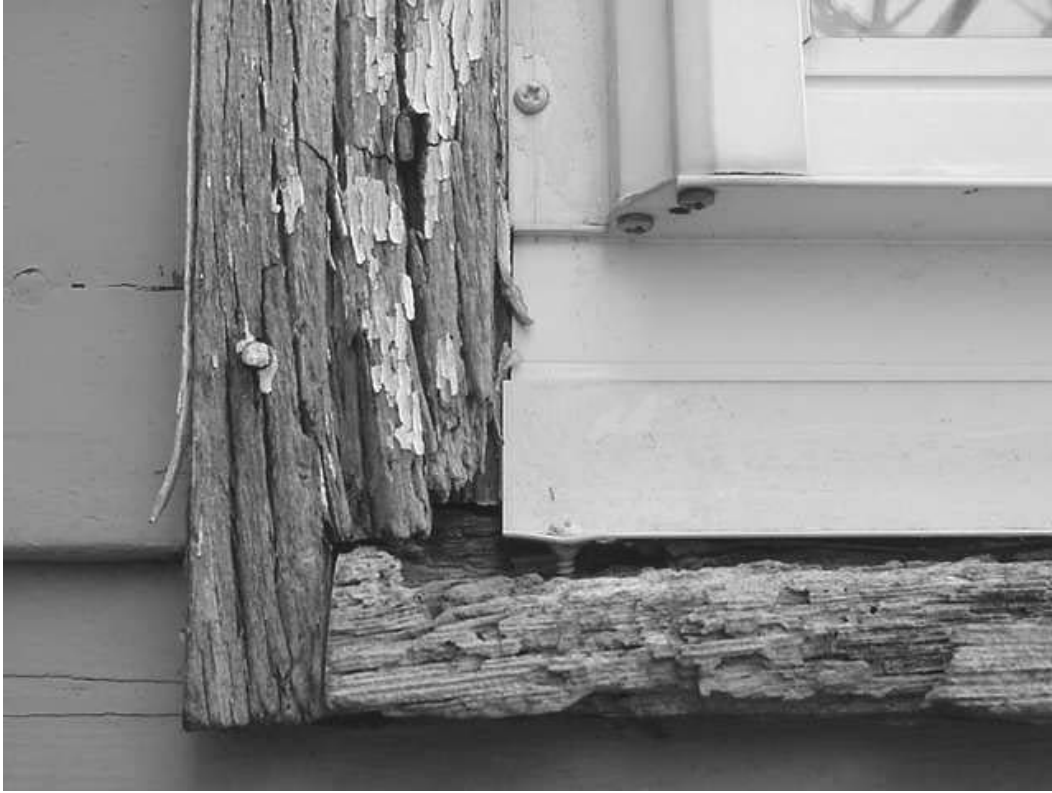
**Picture 10**

**Rotted Wooden Windowsill Note Screws of Windowframe are Exposed**

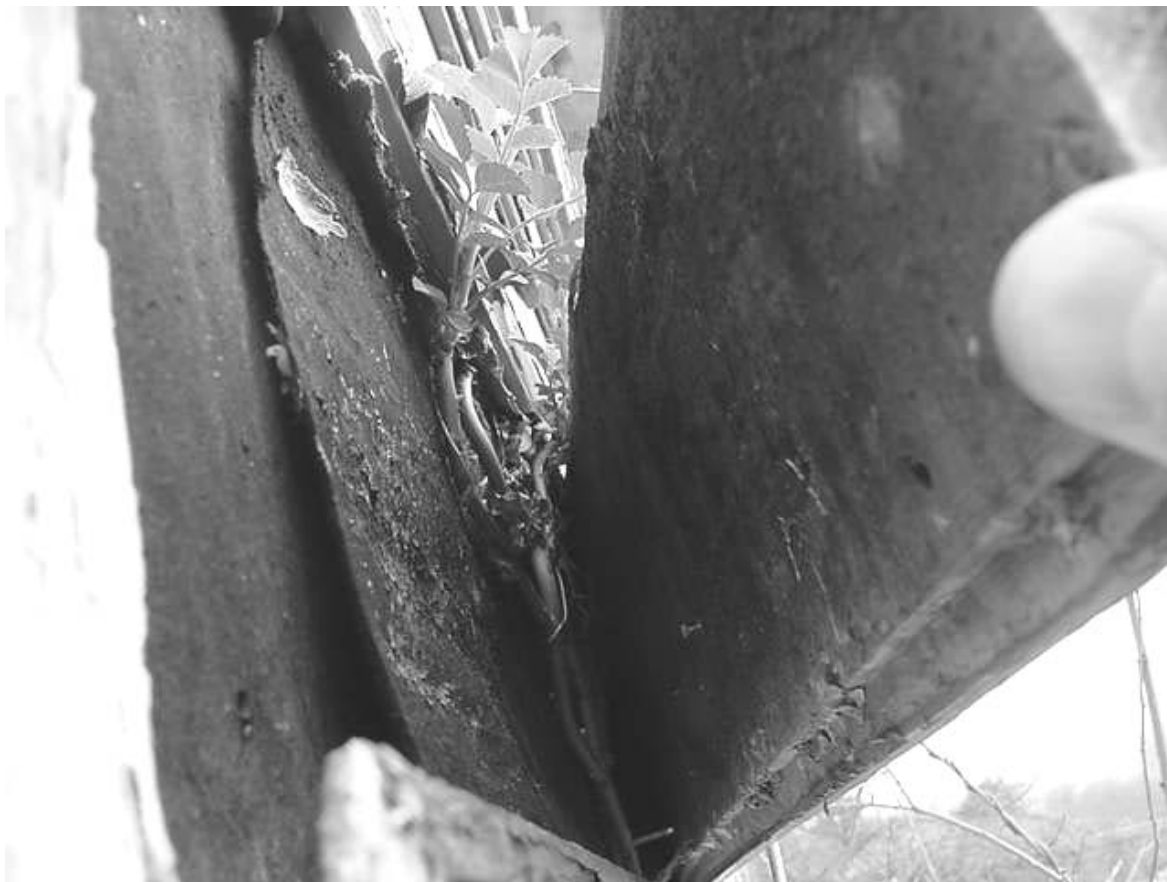
**Picture 11**

- Trees and other plants exist in the tarmac/exterior wall junction. In some cases ivy was growing up the exterior wall and had penetrated wooden paneling (see Picture 11). The growth of roots against the exterior walls as well as spaces between the tarmac and

exterior walls of the building can bring moisture in contact with building materials and eventually lead to breaches of the building envelope resulting in water damage and subsequent microbial growth.

**Ivy Growth beneath Wooden Siding**

8. Remove plant growths against the exterior wall/foundation of the building to prevent water penetration.
9. Use integrated pest management (IPM) to remove pests from the building. A copy of the IPM recommendations is included with this report as [Appendix II](#) (MDFA, 1996).

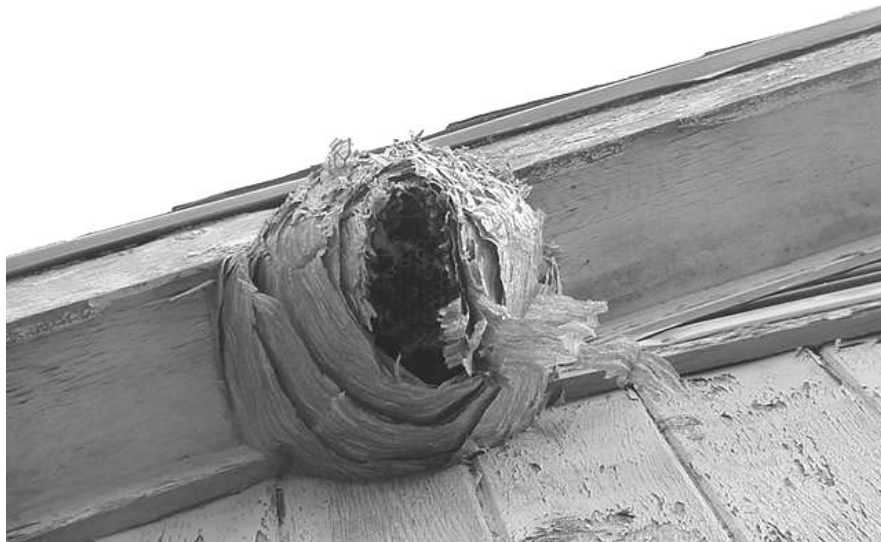
**Picture 12**

Many flying insect nests (e.g., bees, hornets, wasps) were observed around the perimeter of the building (see Pictures 12 & 13). These nests should be removed to prevent potential problems in a manner as to not introduce pesticides and/or insects into the building. Under current Massachusetts law that went into effect November 1, 2001, the principles of integrated

**Large Hornets/Wasp's Nest beneath Roof Eve**

Activities that can be used to eliminate pest infestation may include the following activities.
  - i) Consult a licensed pesticide applicator on the most appropriate method to end infestation.
  - ii) Reduction/elimination of pathways (e.g., spaces under doors)/food sources that are attracting pests.

iii) Reduce harborages (plants/cardboard boxes) where pests may reside.

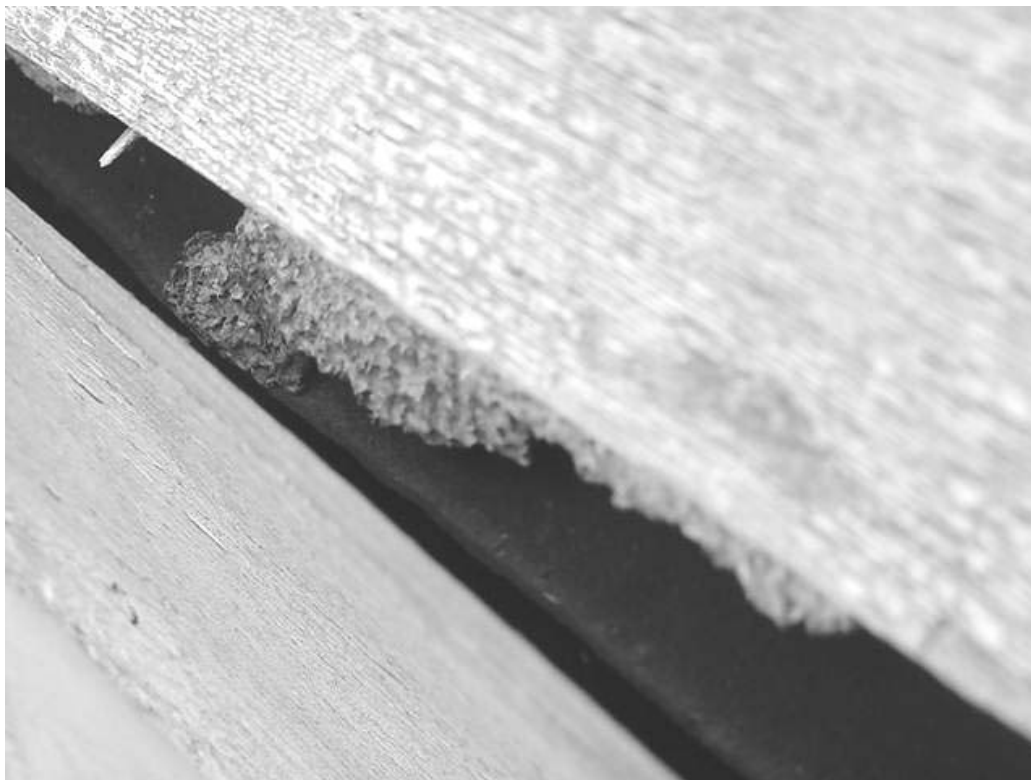
**Picture 13**

**Bees Nest beneath Detached Wooden Siding**
